LONGTOWN, HEREFORDSHIRE

A medieval castle and borough

Archaeological Investigation Report Series AI/26/2003

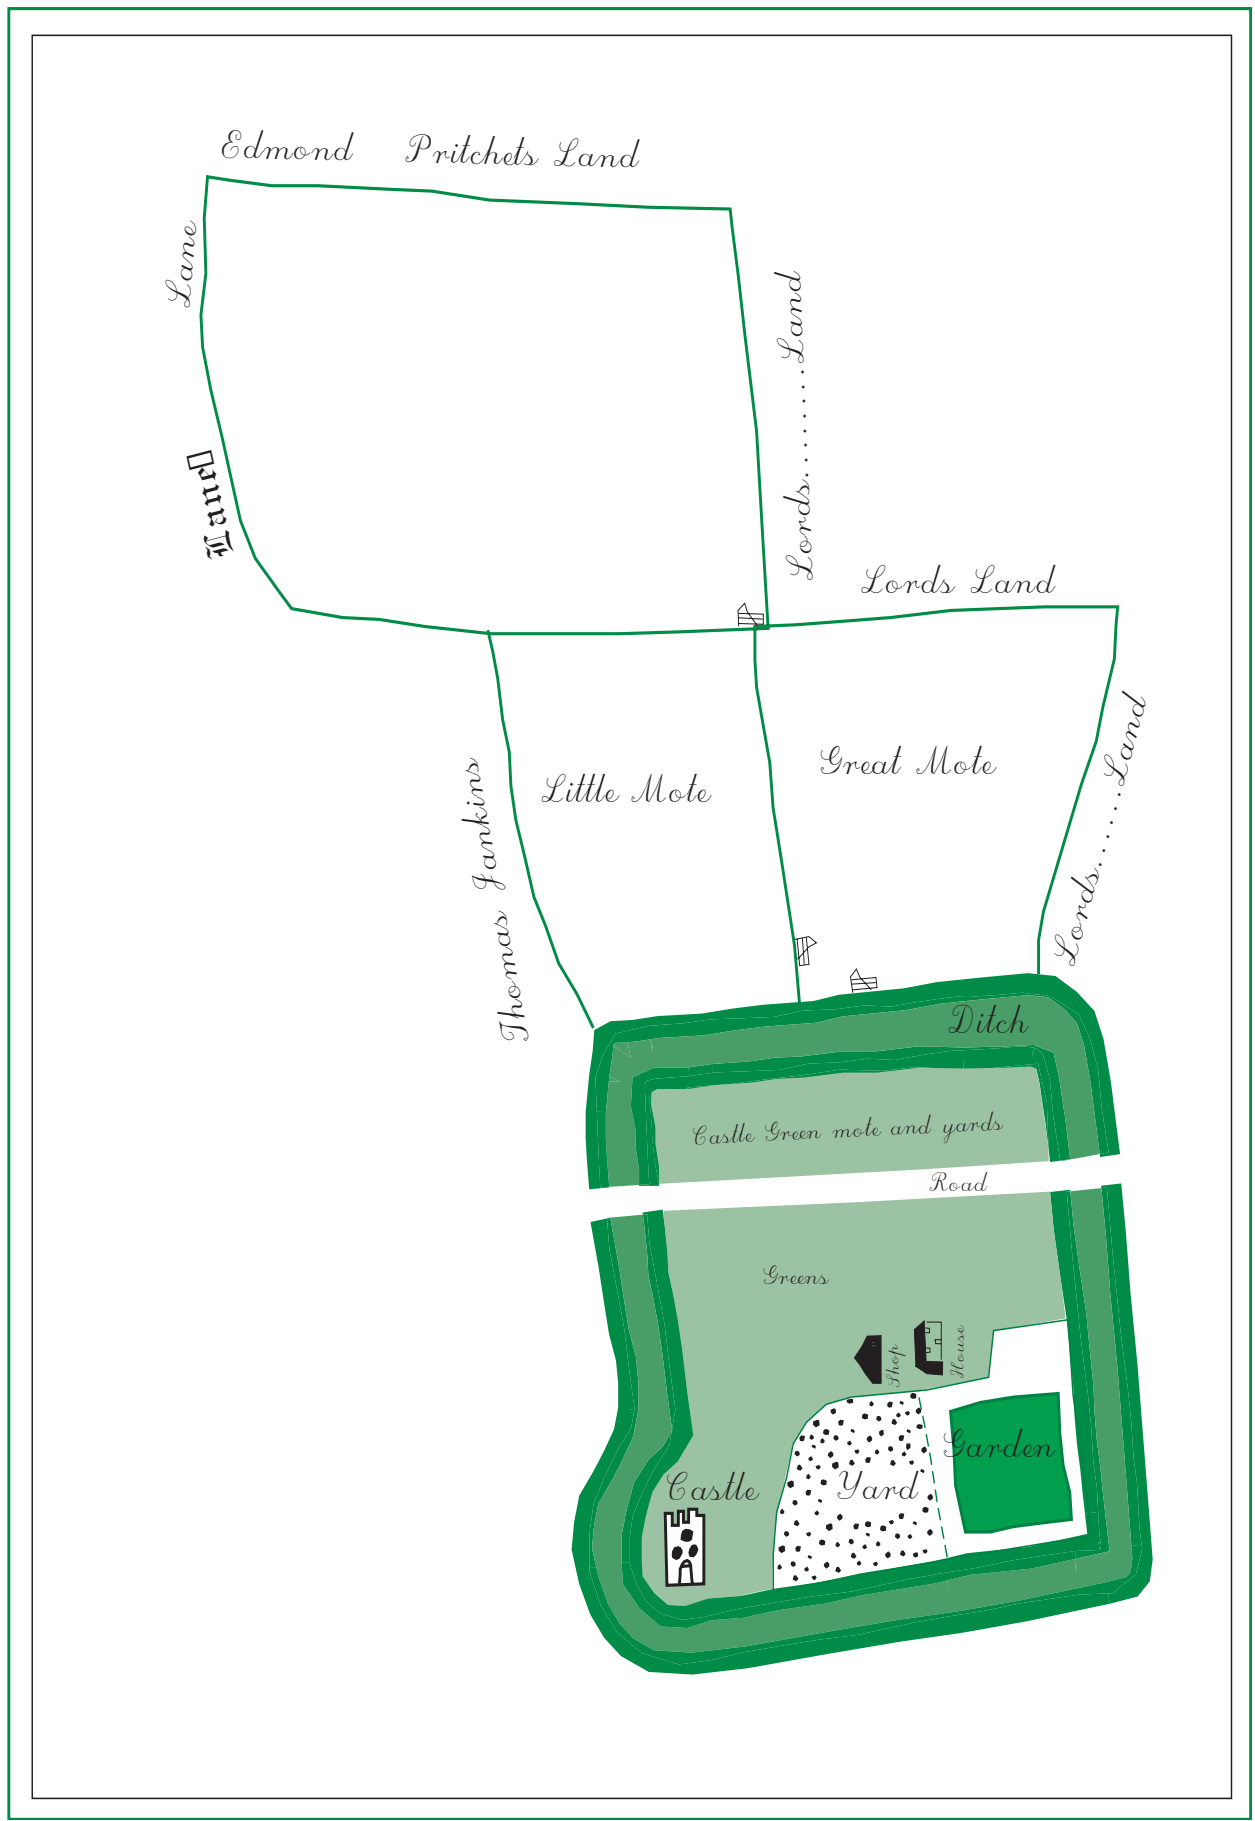
Figure 2: Longtown Castle in 1718. North is to the left (drawing based on map by B Fellowes in British Museum)

The earthwork remains surviving within the inner and outer baileys are few. The cross-wall, and its collapsed masonry, cuts across a generally scooped ground profile within the combined baileys, the ground rising gradually, but significantly, around the sides of the enclosures. Other features noted within these baileys were piles of rubble (Figure 3, w) immediately south of the cross wall. A building platform and footings (Figure 3, x) to the south-east of the inner bailey gateway appears to be the site of a house depicted on early maps (eg Figure

2). A small section of wall from the footings of this building survives. The structure may be the remains of a castle building, or perhaps the ancient house used for meetings of the manorial court of Ewias Lacy after the castle was disused and leased out (above p9). It is, however, clearly of a different phase to the curtain wall joining its southern face. This has been re-used as the wall of a lean-to cottage or farm building (Figure 3, y) which was attached to its outer face. The southern and western walls of its yard delimit a platform, levelled when it was cleared of builders' rubble in 1995 (Appleton-Fox 1995). This building appears to have been short-lived. It was depicted on only a map of 1904 (Ordnance Survey), although its yard walls already existed by the time of the first large scale detailed survey of the area (Ordnance Survey 1888). Further features are visible on the eastern side of both the inner and outer baileys (Figure 3, q). These appear on the ground as shallow linear undulations associated with parch marks, suggesting that wall footings lie just beneath the ground surface. Given the depth of overburden which has accumulated over the medieval deposits in the baileys (above p12), it is likely that these features are the remains of later farm buildings.

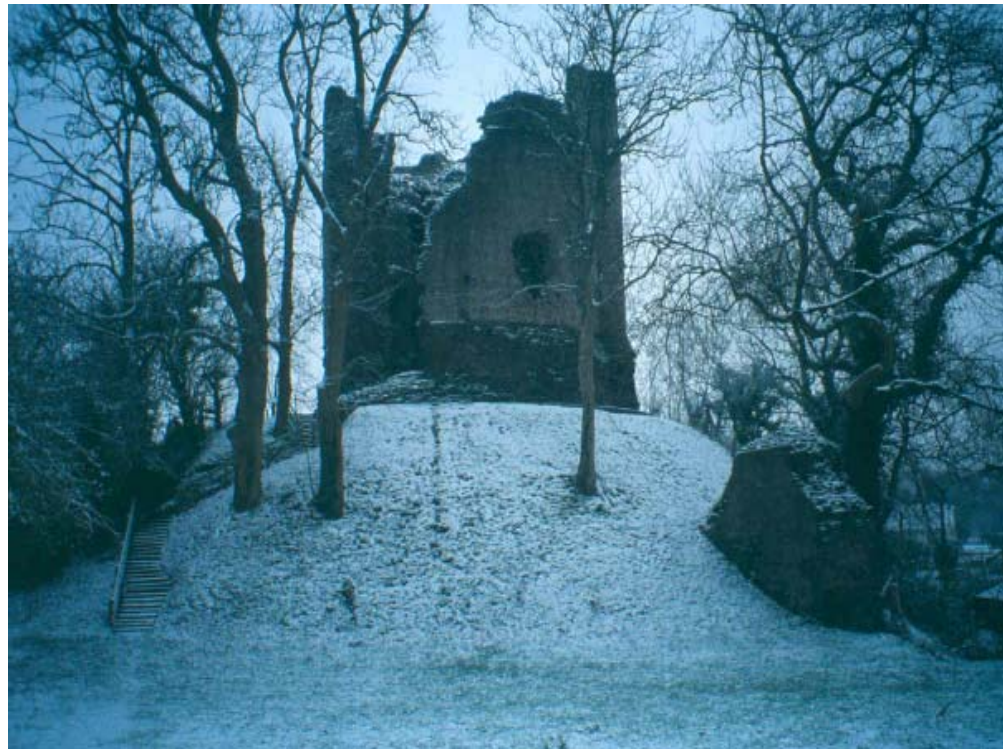
Figure 4:
*Longtown
motte and
keep*

The steep conical castle motte straddles the north-western corner of the enclosure. It is an imposing feature, standing approximately 11m high, with a circular stone keep on its summit. Its ditch has been filled in but traces of it can be seen in the inner bailey where a broad shallow depression (Figure 3, l), at most 0.3m deep, curves around the foot of the mound. Further traces can be seen to the west, where a further shallow ditch (Figure 3, m) lies between Jews Lane and the mound and also where the enclosure rampart has been cut immediately to the south of the mound (Figure 3, n). As with the main enclosure ditch, the motte ditch carries a track on its northern side which has been partly filled in to accommodate houses and gardens behind a wall. This wall retains an external ground level of 1.7m.

The keep is a massive round structure constructed of local shale-like sandstone rubble with ashlar dressings. It has been the subject of several detailed studies (eg Morriss & Williams 1991; Remfry 1997, 34-35, 39). Its walls, 4m thick, survive two storeys high above an under-croft which penetrates its earthen mound. It has suffered partial collapse on its south-western side, where two large fragments of masonry (Figure 3, o) lie on the slopes of the motte. The positions of the floor levels are marked by ledges in the interior. Three half round turrets are equally spaced around the outside face of the tower, one containing a fireplace, one a spiral staircase leading to the upper floors and one situated next to a projecting garderobe. The turrets do not show on the ground plan because the keep has a chamfered plinth. This is now robbed of its facing stone. The first floor windows have been enlarged at some point and decorated with fragments of re-used 12th-century mouldings. The 13th century, the date of the earliest fabric of St Peter's Church, would seem a likely date for these modifications because episodes of church re-building may coincide with modifications to the seignorial site, perhaps using the same craftsmen (Creighton 2002, 110). The re-used masonry may have come from a 12th century chapel, perhaps situated within the castle. Chapels tended first to be in the keep and from the 13th century onwards at the side of the bailey and against an exterior wall (Pounds 1990, 240). Round keeps are rare and the example at Longtown is one of a group of 19 such keeps to have been recognised in the Brecon region (Shoesmith 1996, 170).

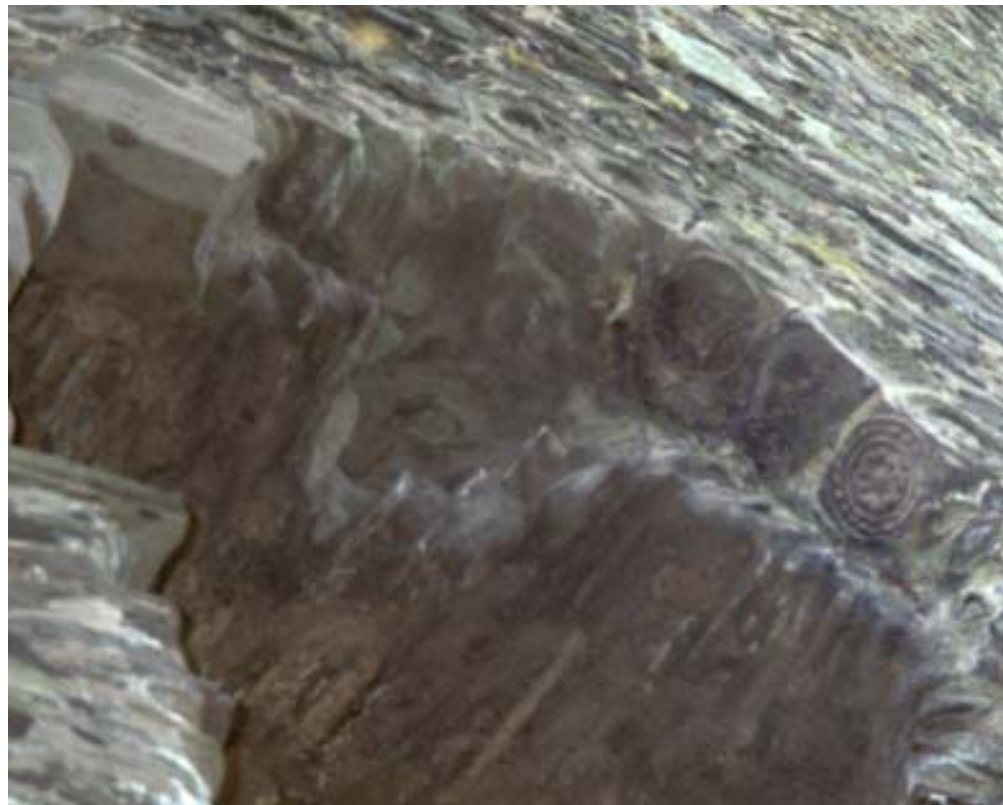
Figure 5:
*re-used
12th-
century
mouldings
in keep
window*

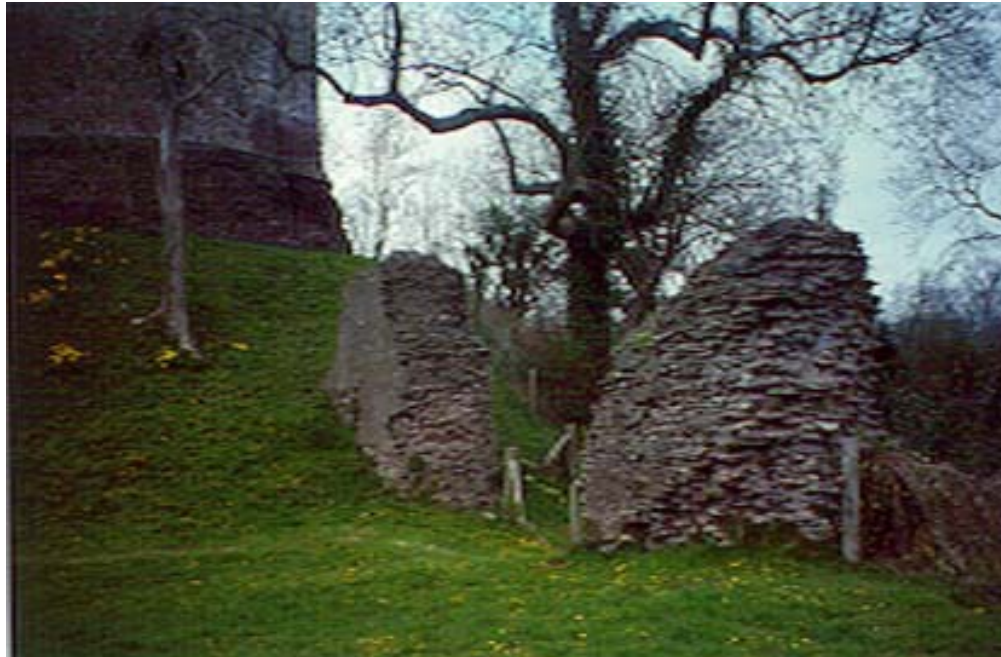
Figure 6:
fragments of curtain wall on the eastern side of the inner bailey

A masonry curtain wall, approximately 3m thick enclosed an irregularly shaped area south of the keep, encompassing the western part of the earthwork enclosure described above. Until recent times this wall joined the keep (Ordnance Survey 1888) and ran across the former line of the mote ditch, showing that the motte ditch must have been filled in before it

was built. Most of the curtain wall has collapsed, but three sizeable portions (Figure 3, p) survive on its eastern side. These probably owe their survival to later use as walls for lean-to buildings. Internally they have collapsed rubble at their foot, while externally the ground drops away 2m beyond a vertical retaining wall. A fourth fragment of collapsed curtain wall (Figure 3, s) joins a cross-wall (Figure 3, b), which divides the outer bailey from the inner bailey, continues almost as far as the western rampart of the earlier earthwork enclosure before which it has been reduced to earth-covered rubble. There is no indication of any return of the wall towards the keep to form a western side to the enclosure. A low bank (Figure 3, t) could be an indication of its former course, but is probably the remains of a later wall. The cross-wall, unlike the wall fragments to its east, is completely straight in plan and survives remarkably well compared with the rest of the curtain. It still stands up to 4m high and, like the curtain wall, is built of thin slabs of roughly coursed local stone. It is constructed on level ground with no underlying earthwork. On the eastern side of the outer bailey a further fragment of the curtain wall remains and there is a fall in ground level from the outer bailey to the entrance hollow-way (Figure 3, e). The surviving wall fragment has been incorporated into a narrow wall, placed along the top of the rampart. This bears no resemblance to the remains of the curtain wall and is likely to be a post-medieval garden boundary. Further traces of curtain wall, 2.4m wide, have been reported on top of the rampart on the western side of the outer bailey (Ellis 1997, 71). These were not apparent during the present survey, but the rampart is heavily overgrown.

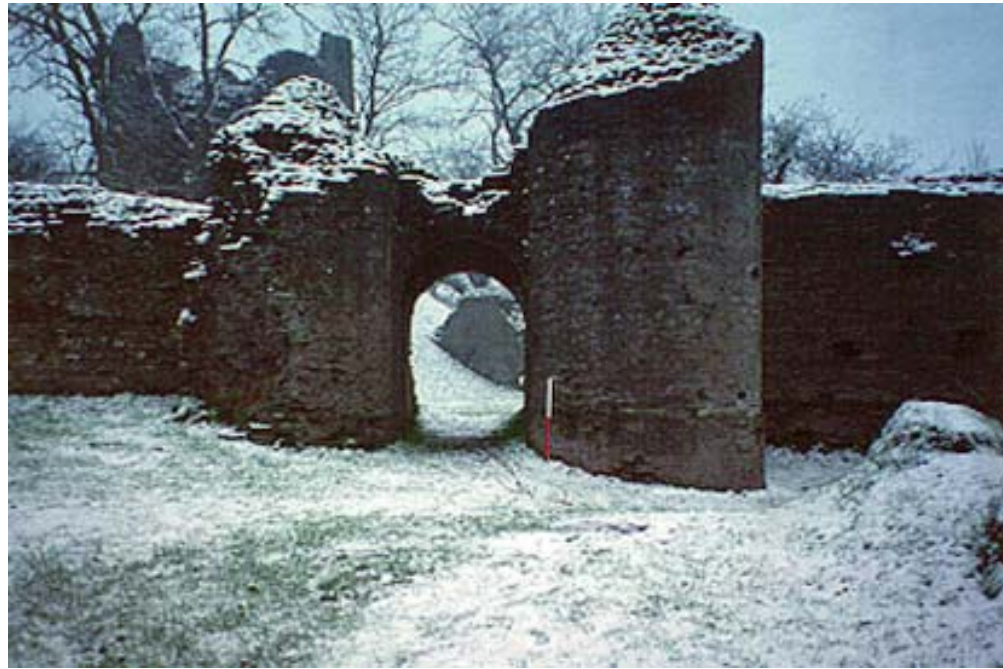
Figure 7:
gateway to
the inner
bailey

The gateway from the outer to the inner bailey (Figure 3, r) has a round-headed arch, flanked by two solid half-round towers. These form its passage, which is flanked by 3m thick walls. It also has a portcullis groove. The gateway does not resemble usual castle entrances. It is extremely small, measuring only 1.8m wide and c2.5m high. However, if the 1m overburden of debris recorded during excavations in the bailey is taken away it would have been high enough for a horseback rider to pass through, although still have been too narrow for any but the smallest of horse-drawn vehicles. It would have offered little defensive potential and has been described as '*perhaps the simplest and smallest example of a twin-tower gatehouse, hardly more than a doorway*' (Cathcart-King 1988, 117).

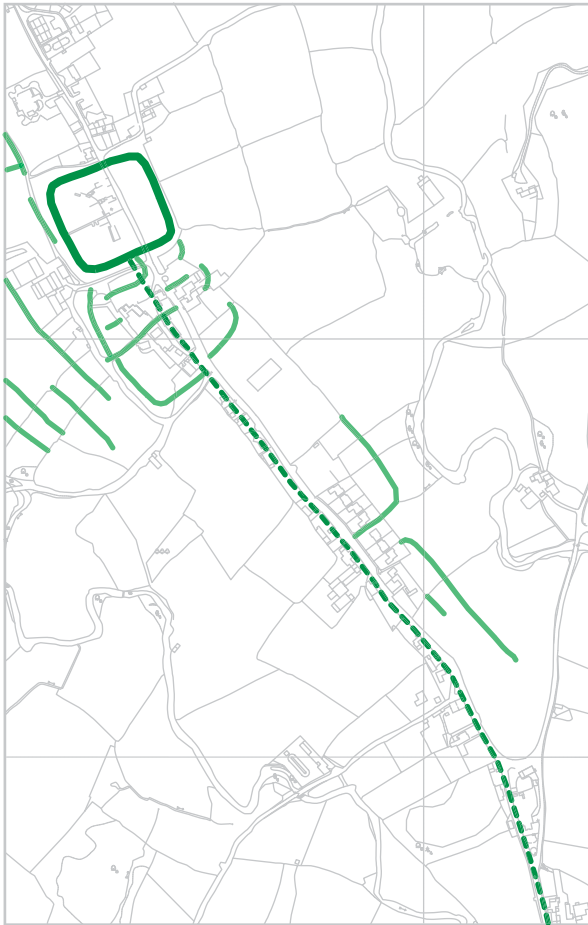
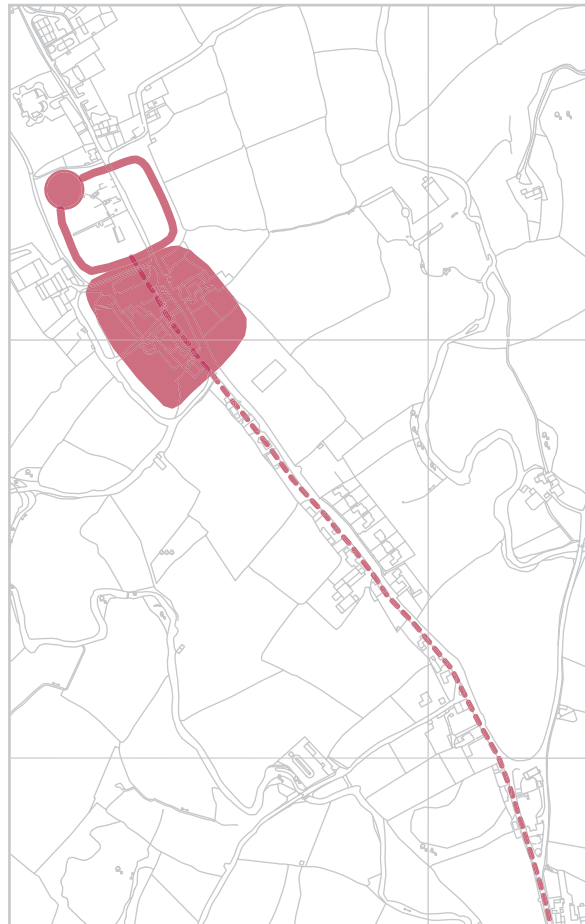
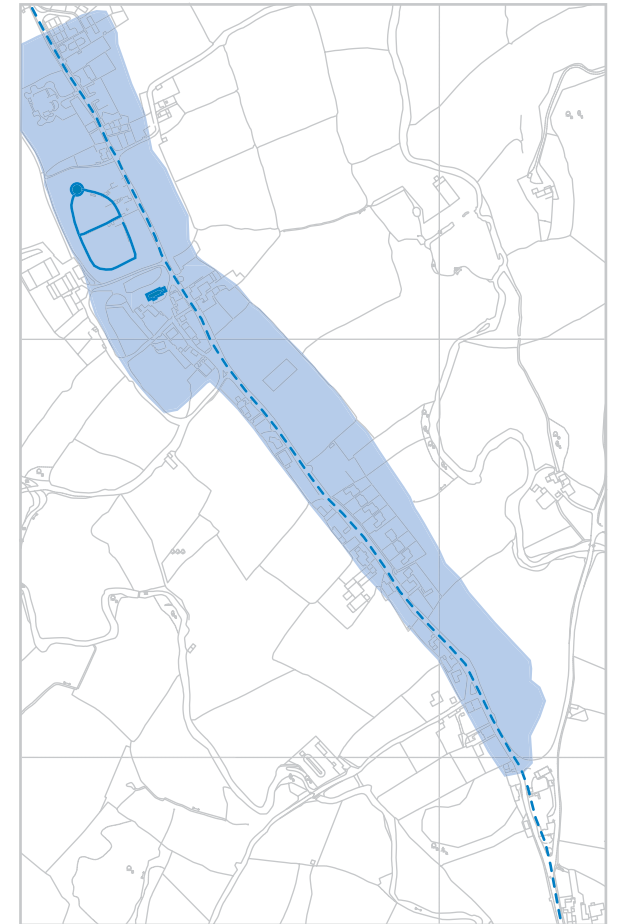
Earthwork castle and early borough
(late 12th century to 13th century)

Masonry castle, chapel and developed borough
(13th century to post medieval period)

Figure 13: Probable sequence of development at Longtown (based on Ordnance Survey maps sheets SO 3228 and SO 3229. Crown copyright reserved)
